COLORADO DIVISION OF RECLAMATION MINING AND SAFETY
MINERALS PROGRAM INSPECTION REPORT

MINE NAME: Centennial Uranium Project OPERATOR: Powertech (USA) Inc.
COUNTY: Weld MINERAL: U TYPE OF OPERATION: NOI
INSPECTOR(S): Allen Sorenson
MINE ID # OR PROSPECTING ID #: P-2008-043
INSPECTION DATE: 5-1-09 DATE OF COMPLAINT: NA
INSPECTOR'S INITIALS: ACS TIME OF DAY (MILITARY): 1500
INSPECTION TYPE CODE(1): MP POST INSP. CONTACTS(2): NO
JOINT INSP. AGENCY CODE(2): NO REASON FOR INSP. CODE(3): IE
WEATHER CODE(4): CL BOND CALCULATION TYPE(5): NN
OP. REP. PRESENT: Michael Beshore and Terry Walsh

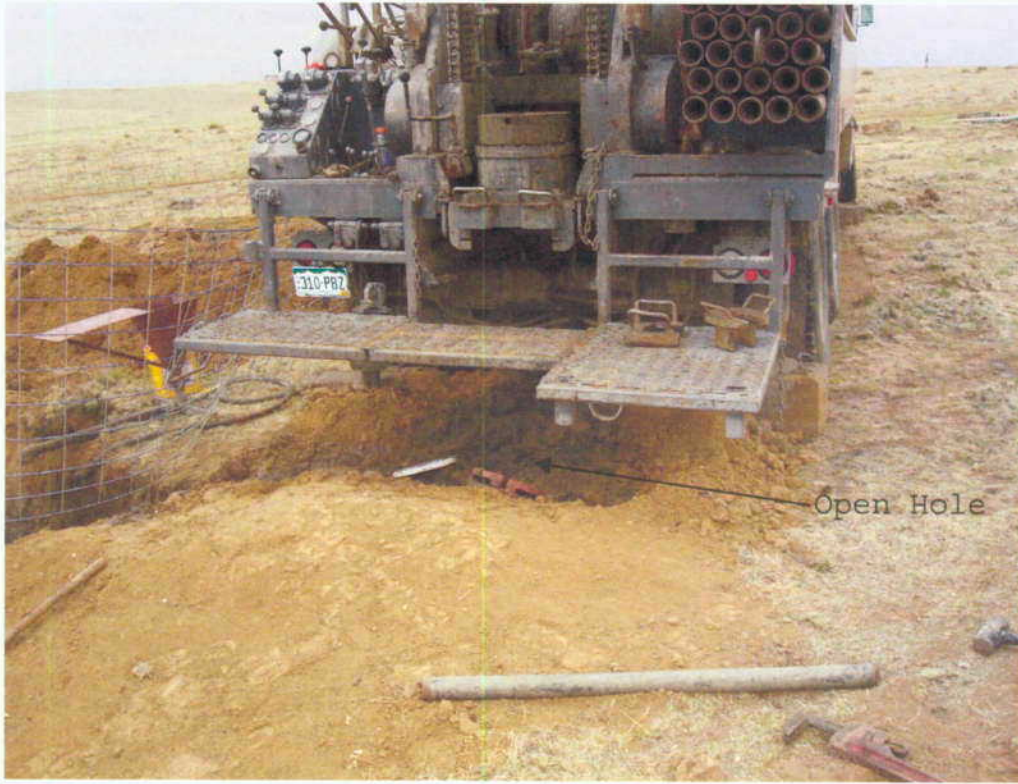
Photo #1: Drill rig, east site

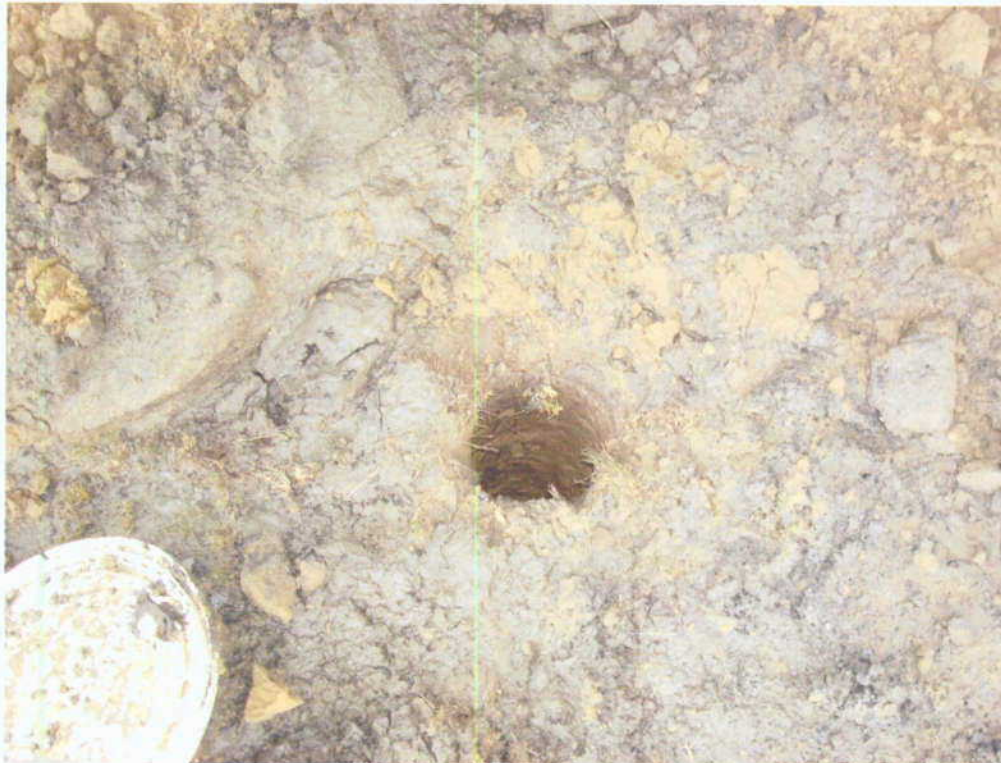
Commencing at 1500 hours, the east and west sites were inspected. There were no personnel on site. The mud pits were fenced at both sites. There were two drill holes observed at the west site. Powertech is approved to drill three monitoring wells at the west site. One of the west site holes was completed; the other west site hole was in the process of being drilled and had been covered using an inverted plastic bucket driven into the surrounding soil and weighted. At the east site, a single hole was in the process of being drilled. The hole was observed to be open. Holes must be securely covered when unattended in order to prevent introduction of contaminants or any unknown substances into the hole. See PB-01 on the fourth page of this report.

1. Open unattended drill hole.

Photo #2: Open hole, east site

Time critical corrective actions were completed prior to inspector leaving site. Further corrective action required is submittal of a report by Powertech describing actions taken to assure that this type of incident will not be repeated.

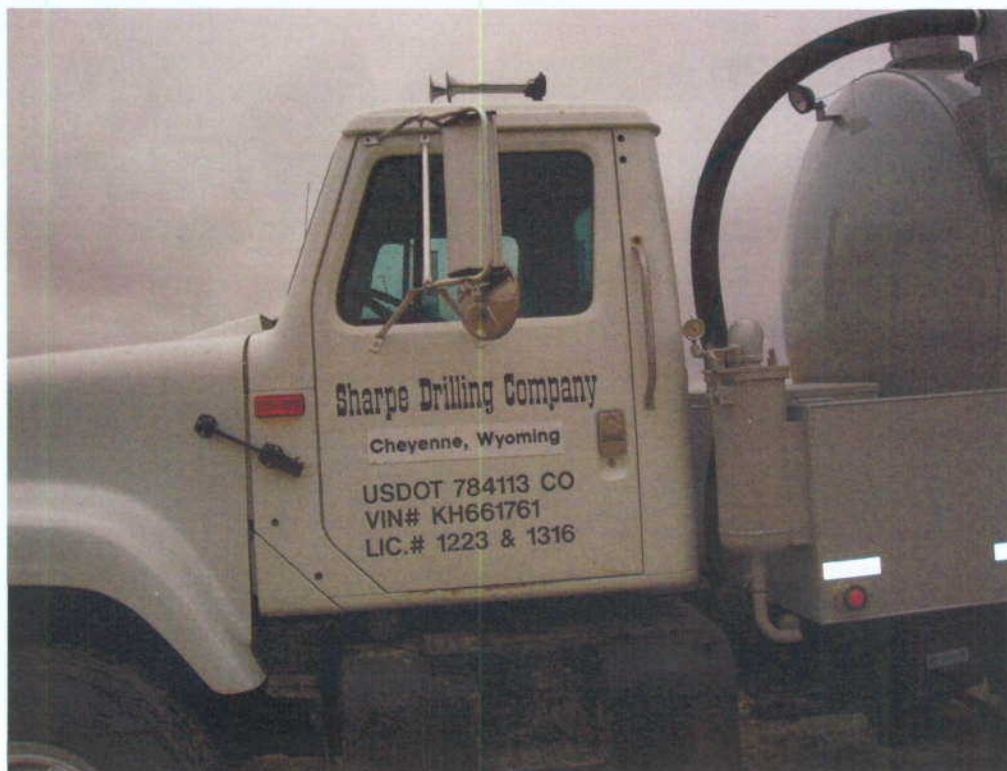
Photo #3: Water truck, east site

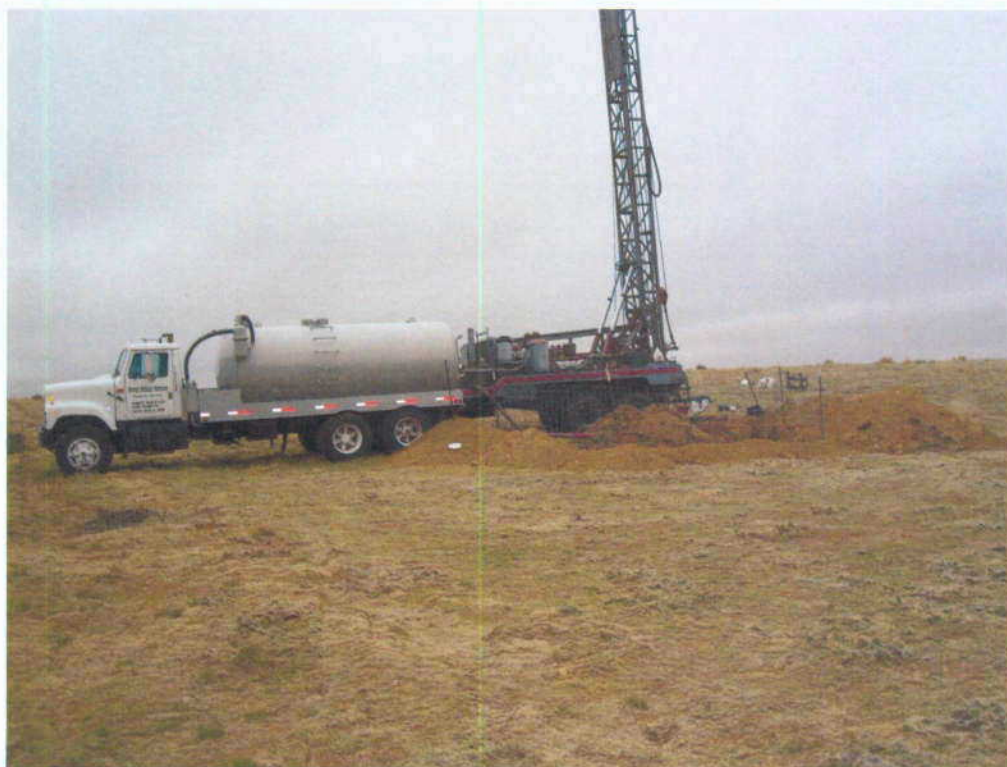
Photo #4: Overview, east site

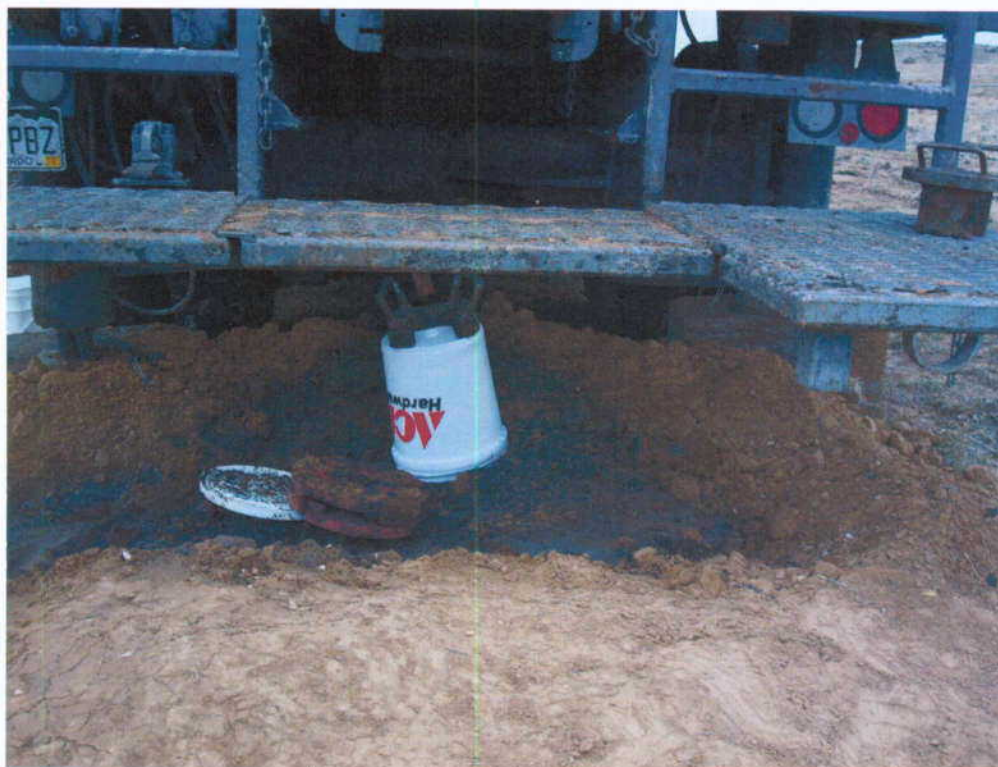
Michael Beshore was contacted by phone at Powertech's Wellington Office at 1514 hours and notified of the open unattended hole. Discussion of how the situation should be remedied ensued, and at approximately 1600 hours Michael Beshore and Terry Walsh of Powertech arrived at the site with new steel pails, five gallon plastic buckets, and a heavy rubber mallet purchased at the Wellington hardware store. An inverted steel pail was driven into the soil around the open hole; a five gallon bucket was then driven into the soil over the steel pail. The

stiffness of the soil prevented penetration of the five gallon bucket more than a few inches past the surface, but it was observed that the steel pail was well embedded. The actions taken were sufficient to prevent rain runoff from entering the hole. Typically, the Division recommends that the drill Kelly be lowered onto hole covers when the drill rig will be unattended, but since there were no drill crew onsite, this could not be done.

Photo #5: Hole covered, east site

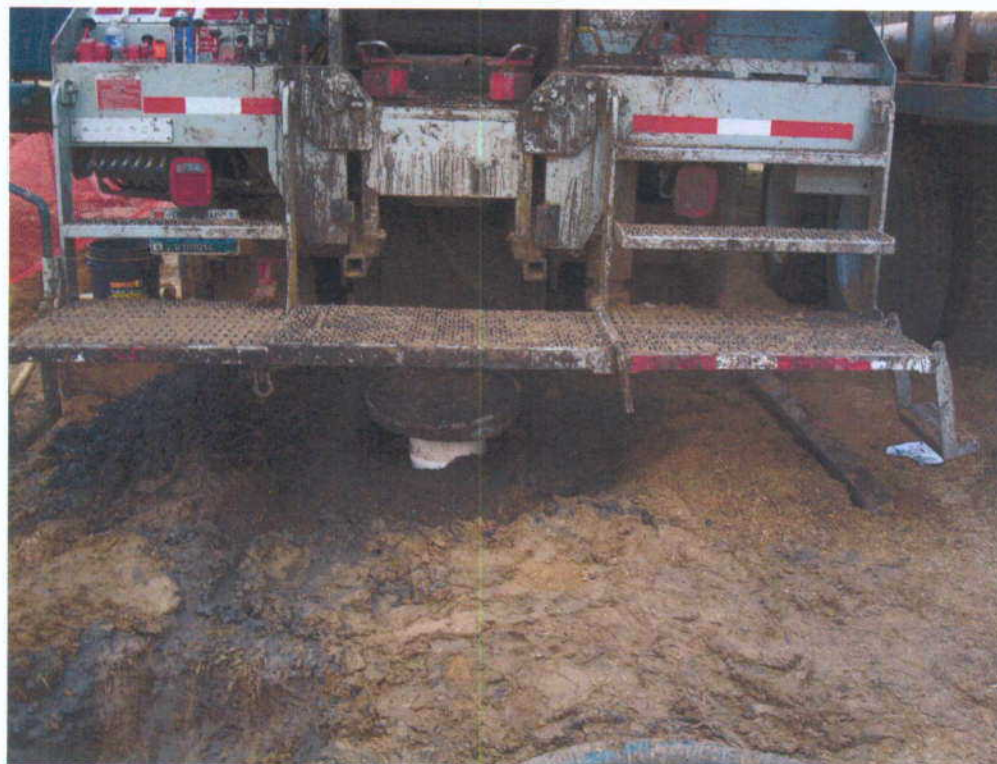
Photo #6: Hole covered, west site

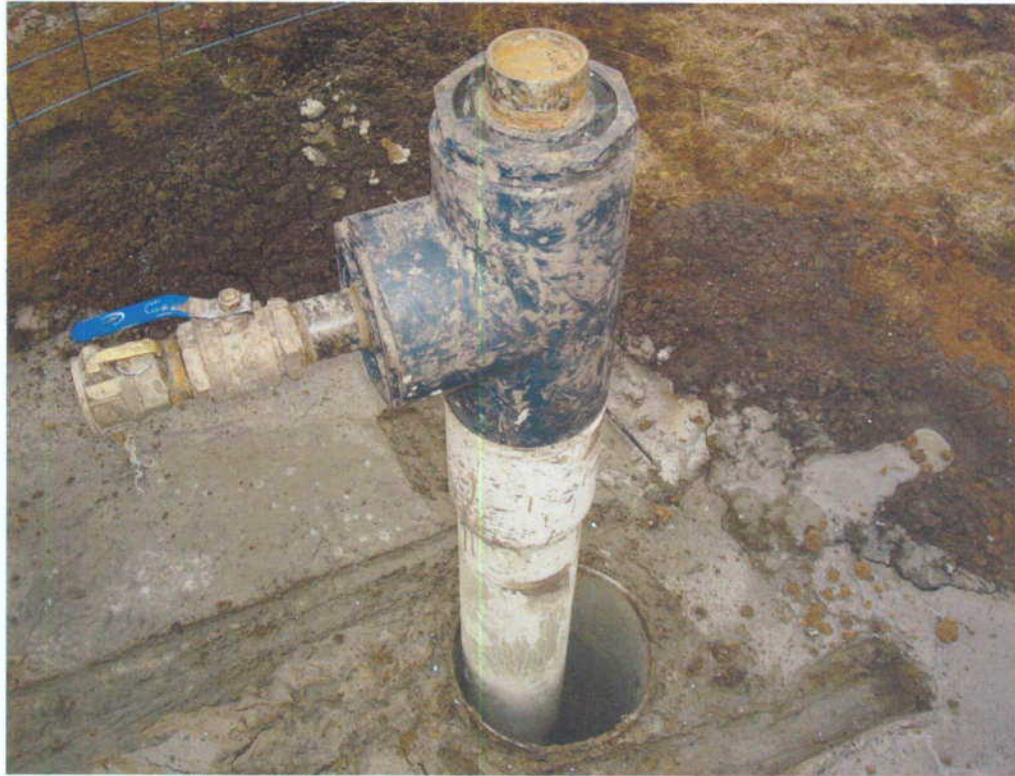
Photo #6: Completed hole, west site

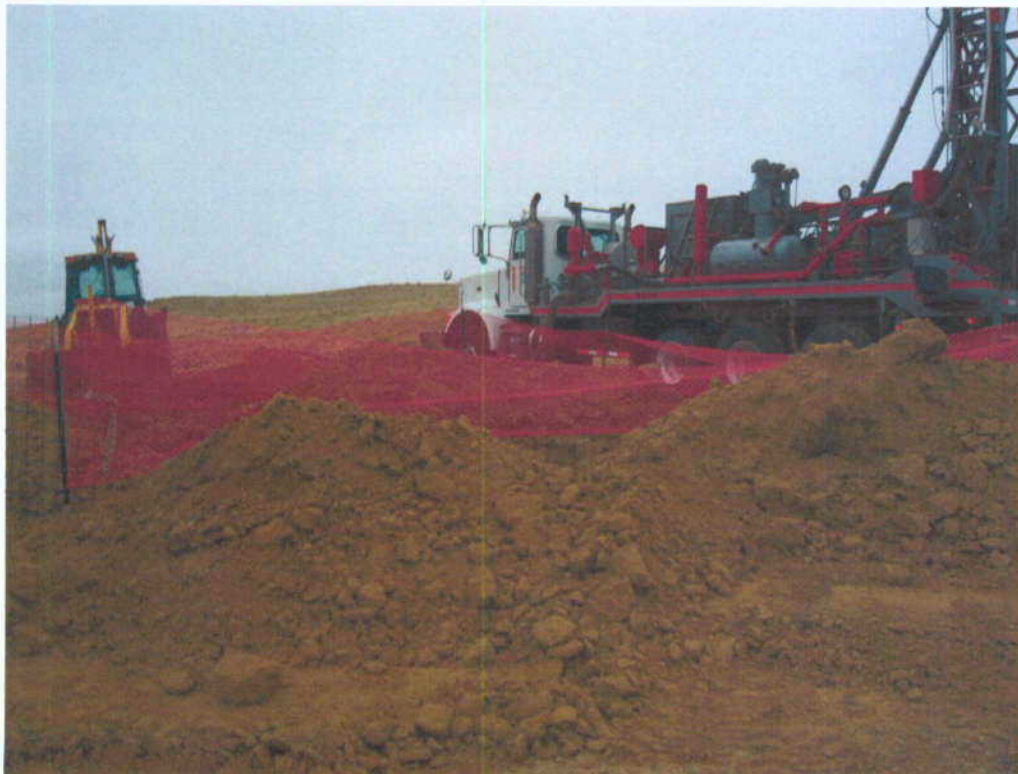
Photo #7: Overview, west site
